**Newport Banning Ranch LLC**

**PHASE I  
ENVIRONMENTAL SITE  
ASSESSMENT UPDATE  
NEWPORT BANNING RANCH  
ORANGE COUNTY, CALIFORNIA**

16 April 2008

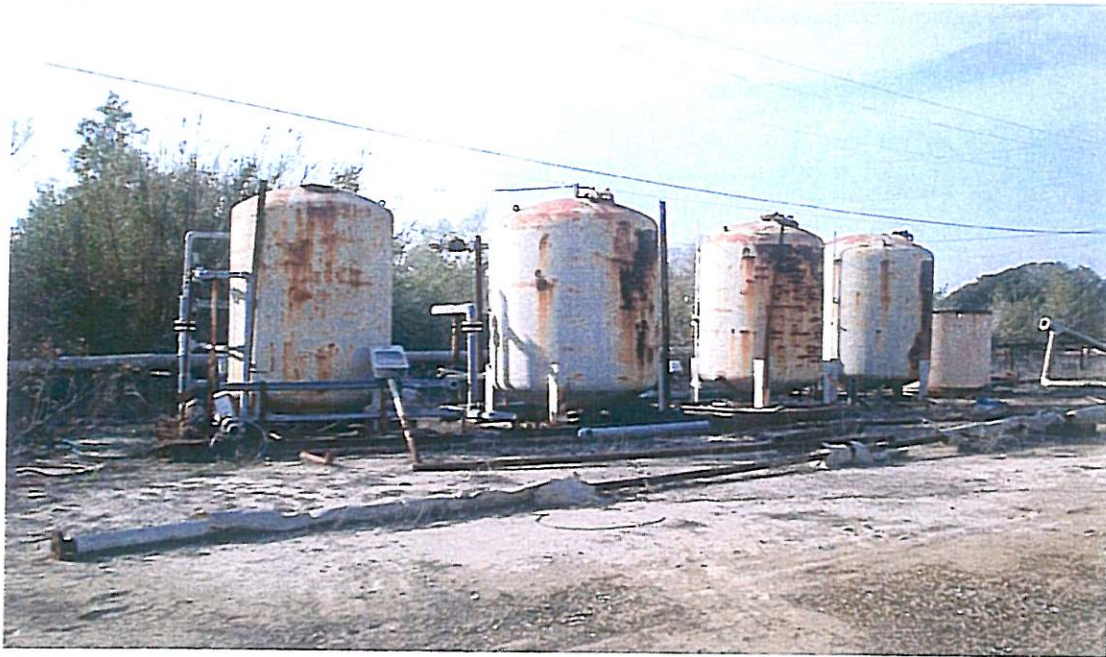
Photo No. 43      Photographer: Ryan Wohlstrom      Date: 12 March 2008  
Description: Miscellaneous Oil Equipment Near Inactive Steam Generation Plant, Looking West.  
Project: Newport Banning Ranch, Orange County, California

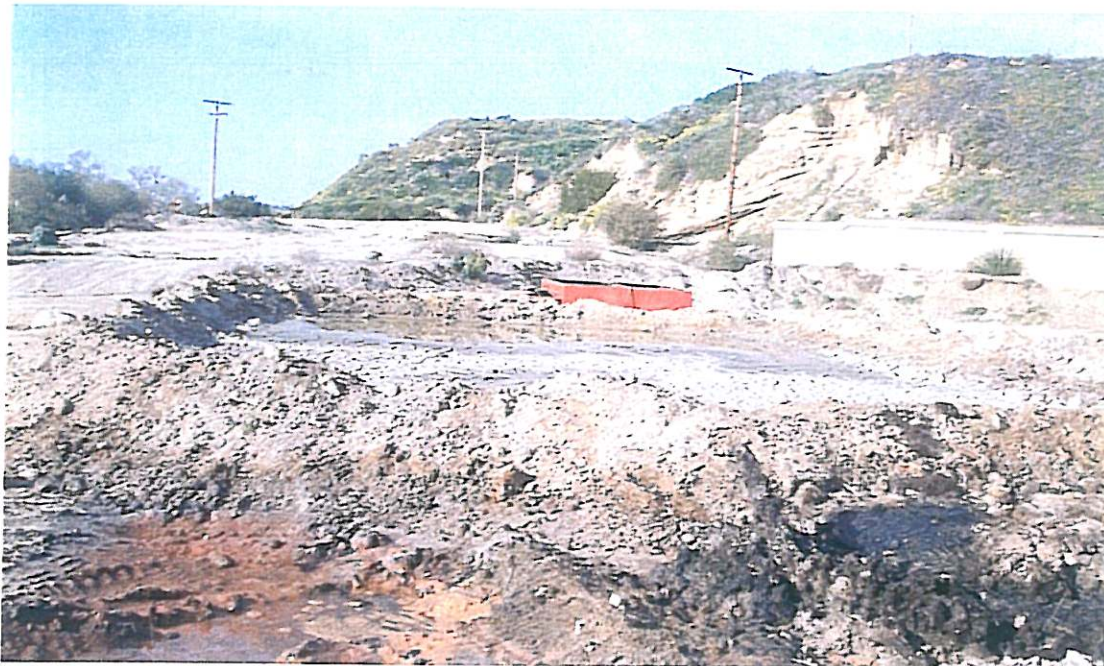
Photo No. 44      Photographer: Ryan Wohlstrom      Date: 12 March 2008  
Description: Impacted Soil Storage Within the Inactive Biotreatment Cell, Looking North.  
Project: Newport Banning Ranch, Orange County, California

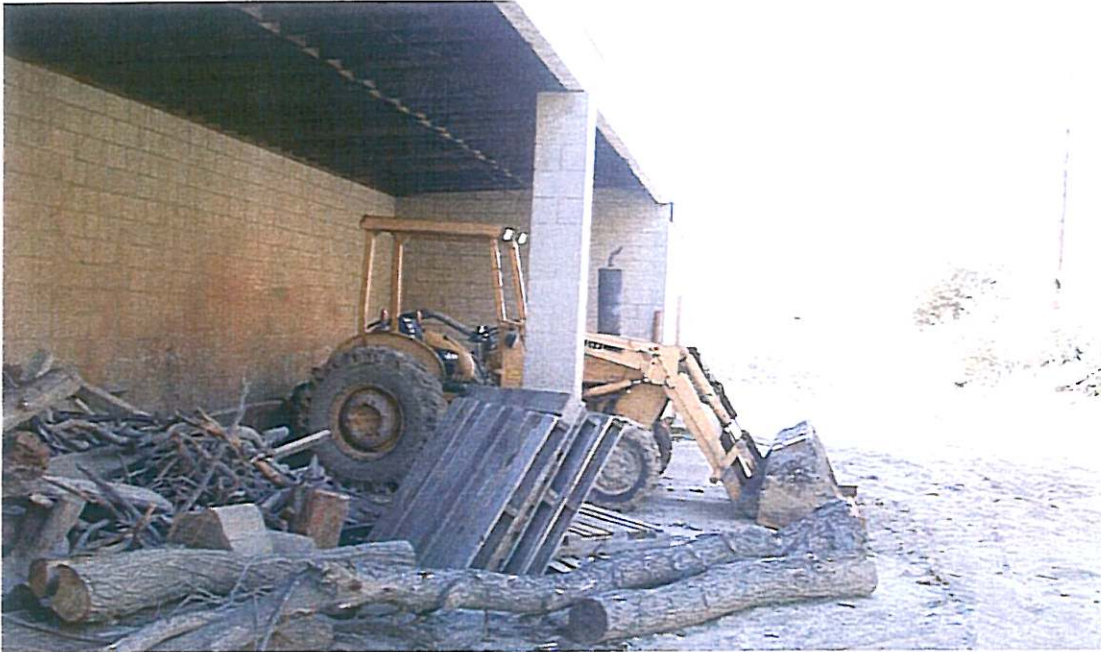
Photo No. 45      Photographer: Ryan Wohlstrom      Date: 12 March 2008  
Description: Contents of Cinderblock Storage Building, Looking North.  
Project: Newport Banning Ranch, Orange County, California

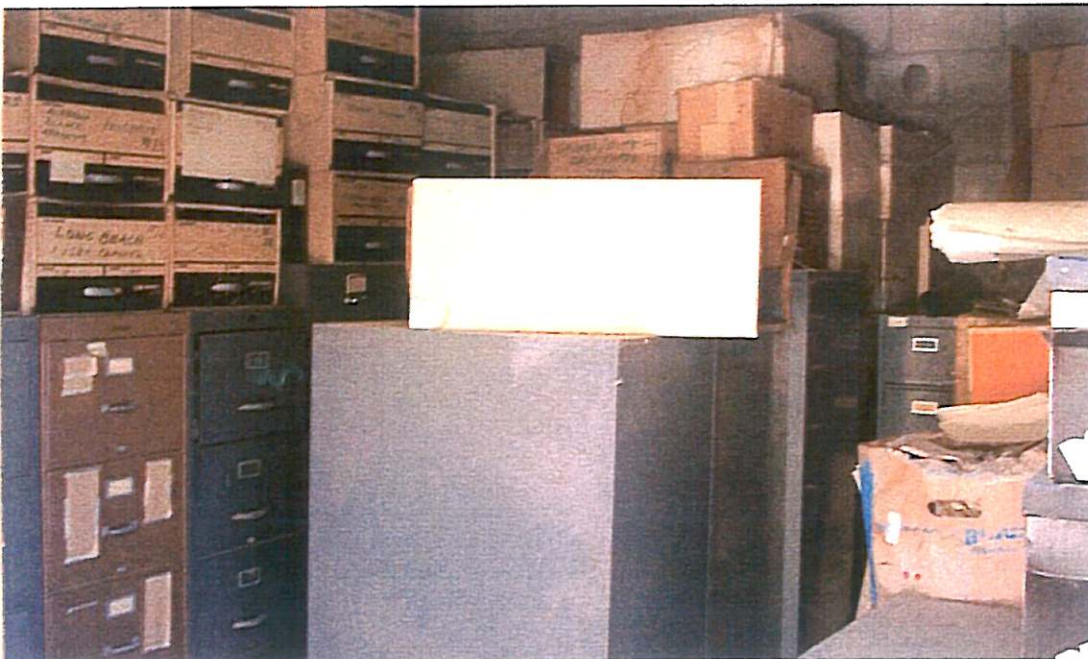
Photo No. 46      Photographer: Ryan Wohlstrom      Date: 12 March 2008  
Description: Contents of Cinderblock Storage Building, Looking West.  
Project: Newport Banning Ranch, Orange County, California

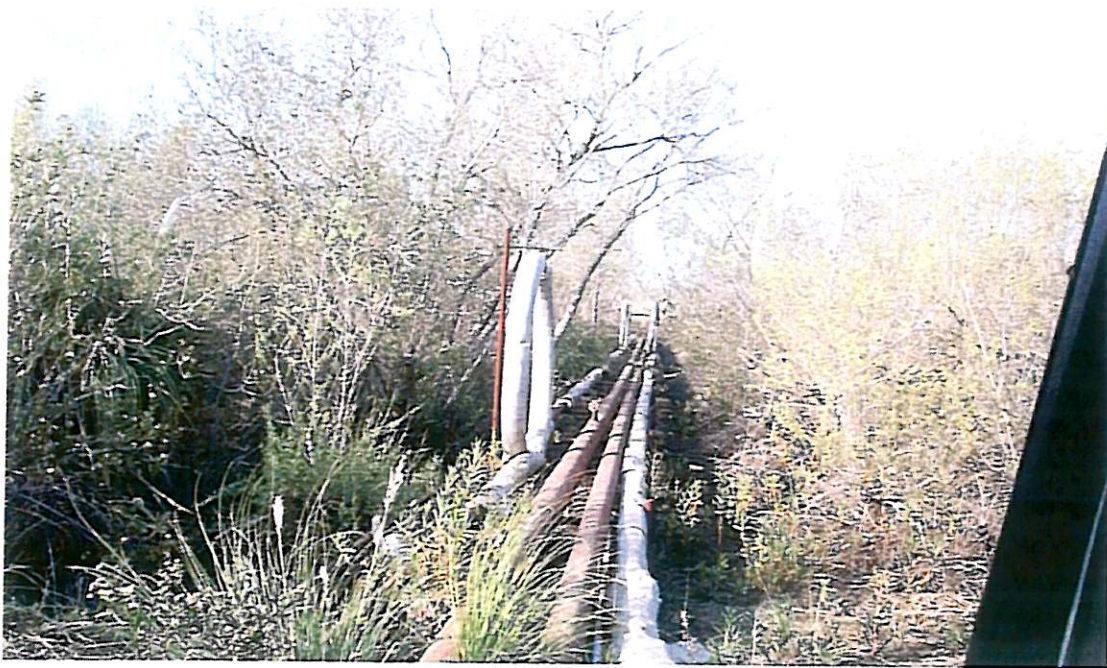
Photo No. 47      Photographer: Ryan Wohlstrom  
Description: Linear Oil Features – Pipelines, etc., Looking West.  
Project: Newport Banning Ranch, Orange County, California

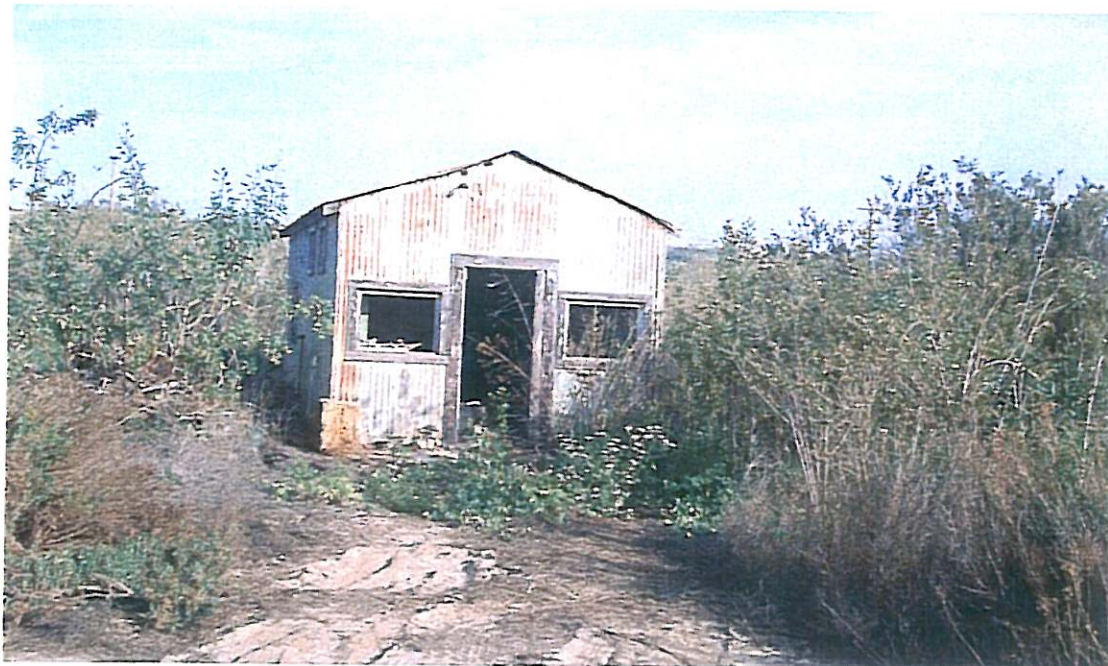
Photo No. 48      Photographer: Ryan Wohlstrom  
Description: Abandoned Shed Near Electrical and Transformer Storage, Looking East.  
Project: Newport Banning Ranch, Orange County, California

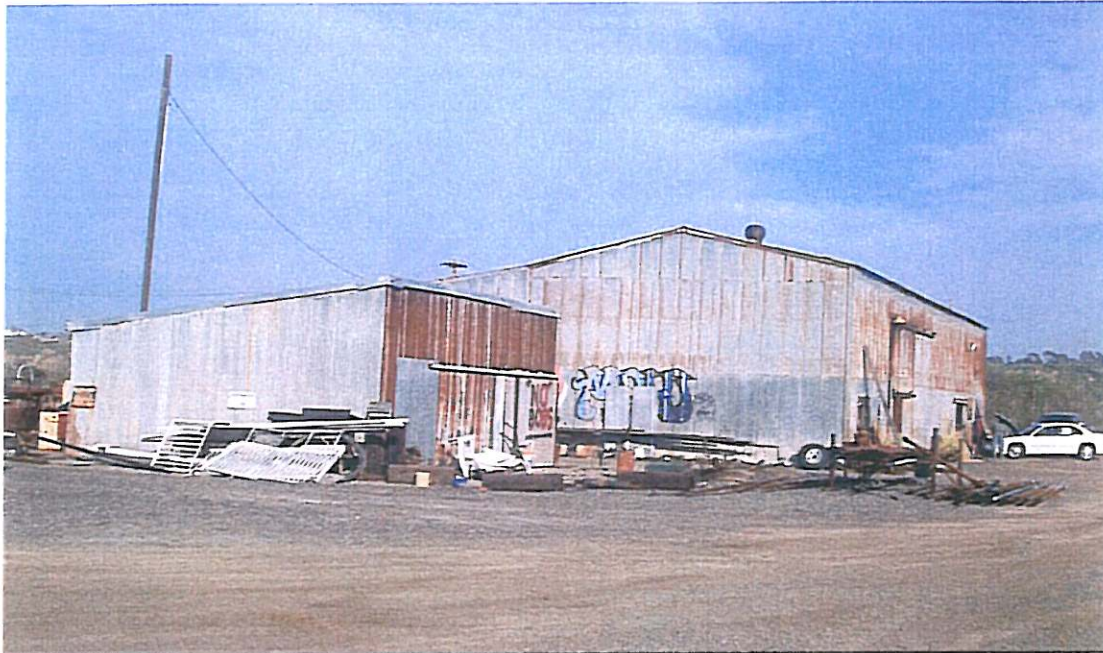
Photo No. 49      Photographer: Ryan Wohlstrom  
Description: Maintenance Shop / Warehouse, Looking Northeast.  
Project: Newport Banning Ranch, Orange County, California

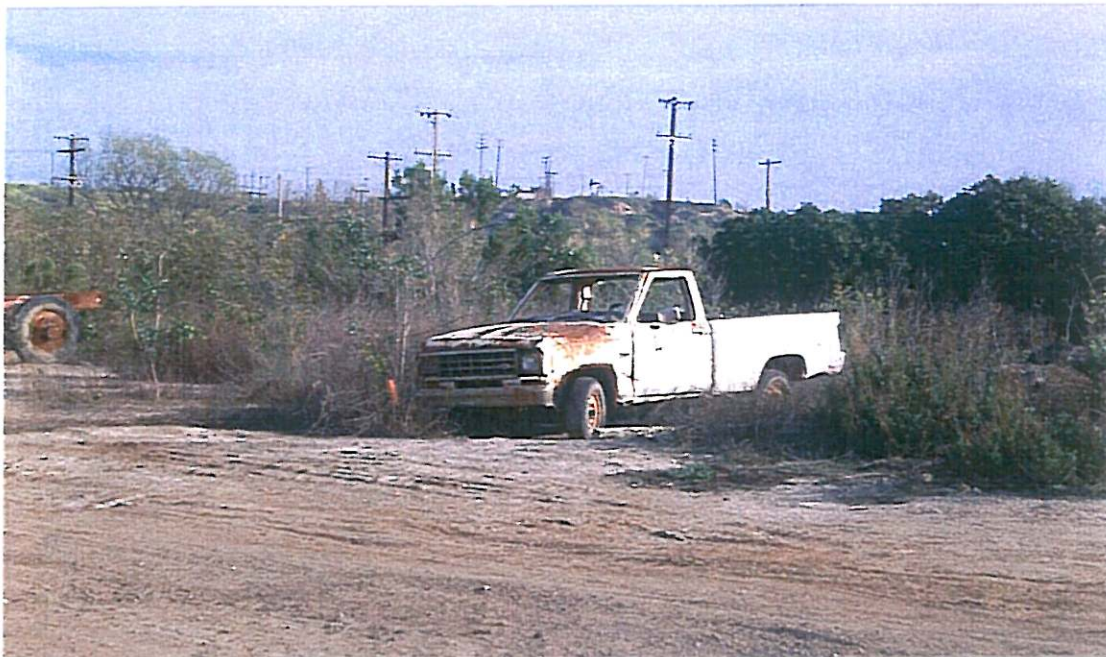
Photo No. 50      Photographer: Ryan Wohlstrom  
Description: Miscellaneous Vehicle Storage Near Warehouse, Looking Southeast.  
Project: Newport Banning Ranch, Orange County, California

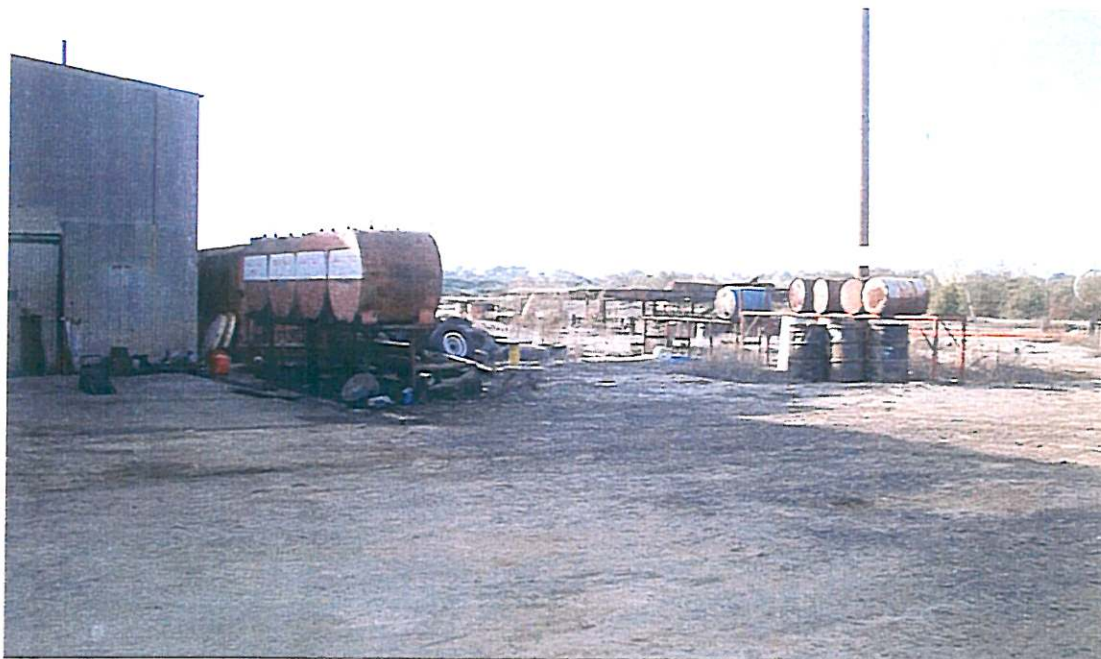
Photo No. 51      Photographer: Ryan Wohlstrom  
Description: Maintenance Shop / Warehouse, Looking West.  
Project: Newport Banning Ranch, Orange County, California

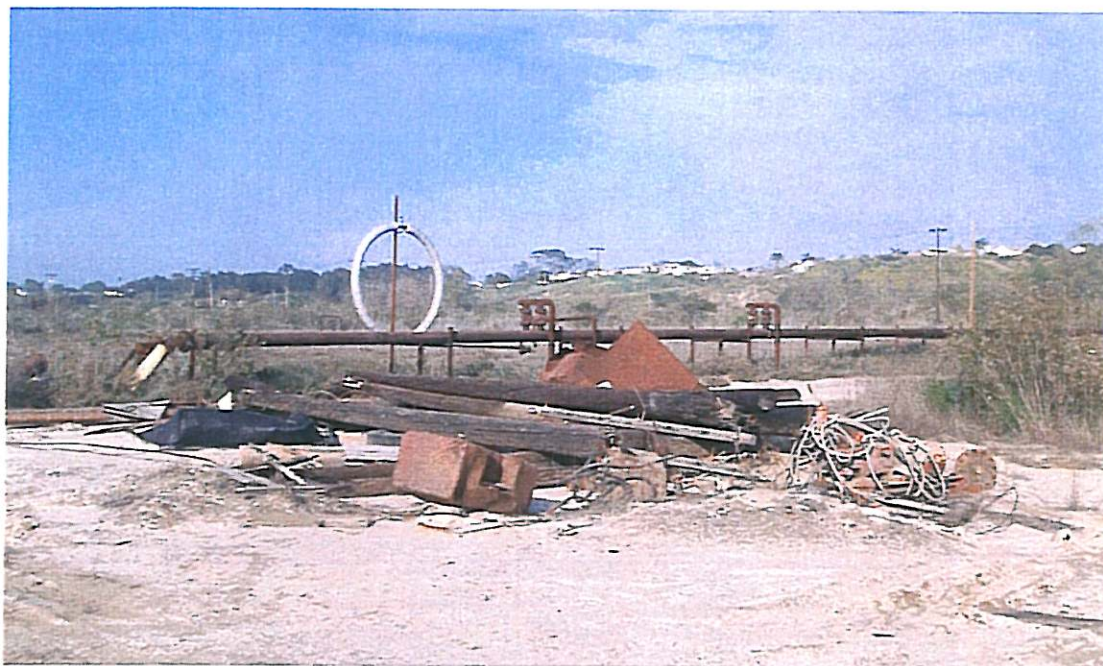
Photo No. 52      Photographer: Ryan Wohlstrom  
Description: Miscellaneous Debris Near Linear Features, Looking Northeast.  
Project: Newport Banning Ranch, Orange County, California

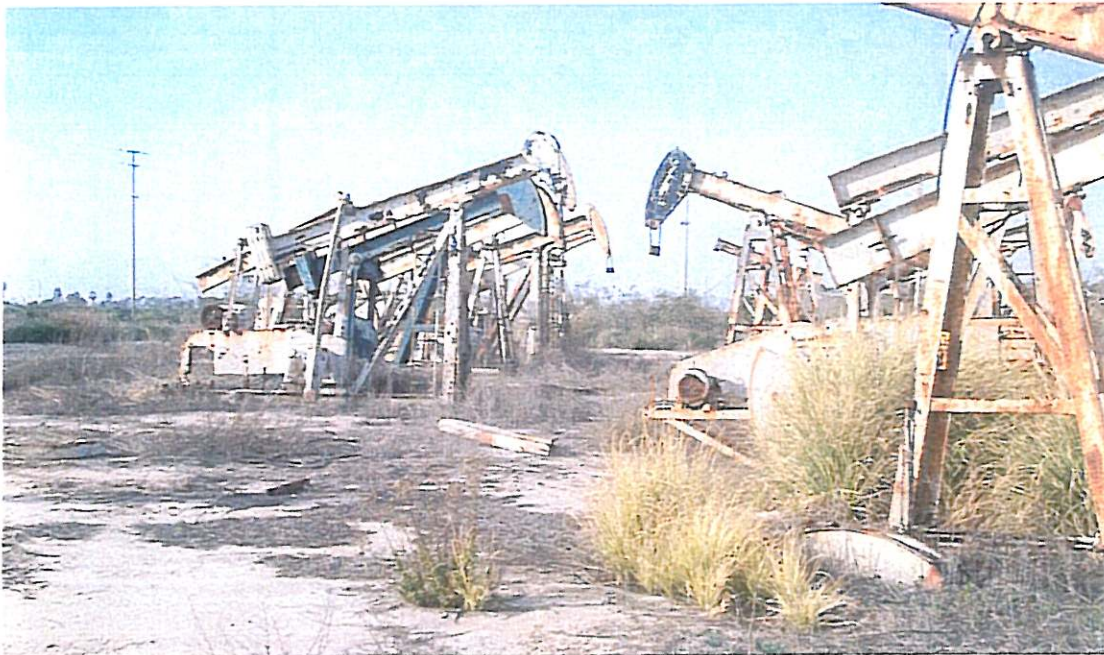
Photo No. 53      Photographer: Ryan Wohlstrom      Date: 12 March 2008  
Description: Oil and Gas Production Equipment Storage, Looking North.  
Project: Newport Banning Ranch, Orange County, California

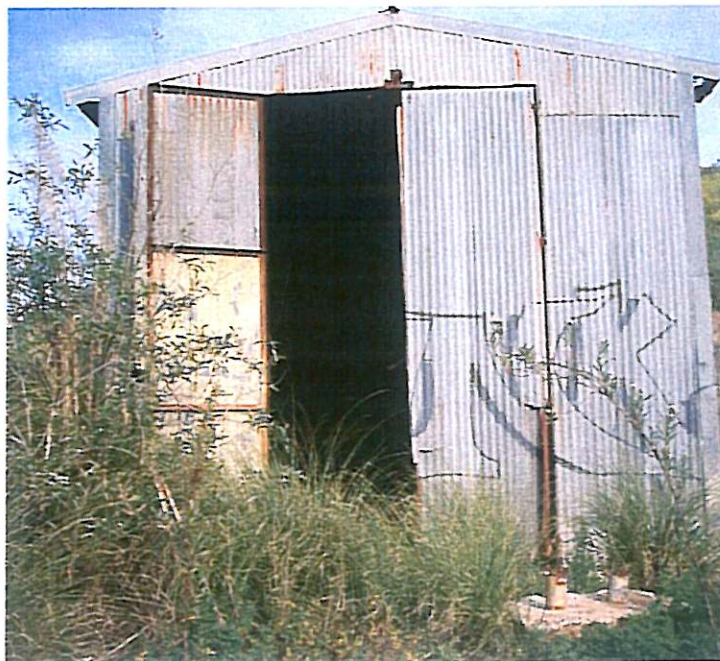
Photo No. 54      Photographer: Ryan Wohlstrom      Date: 12 March 2008  
Description: Abandoned Shack, Looking East.  
Project: Newport Banning Ranch, Orange County, California

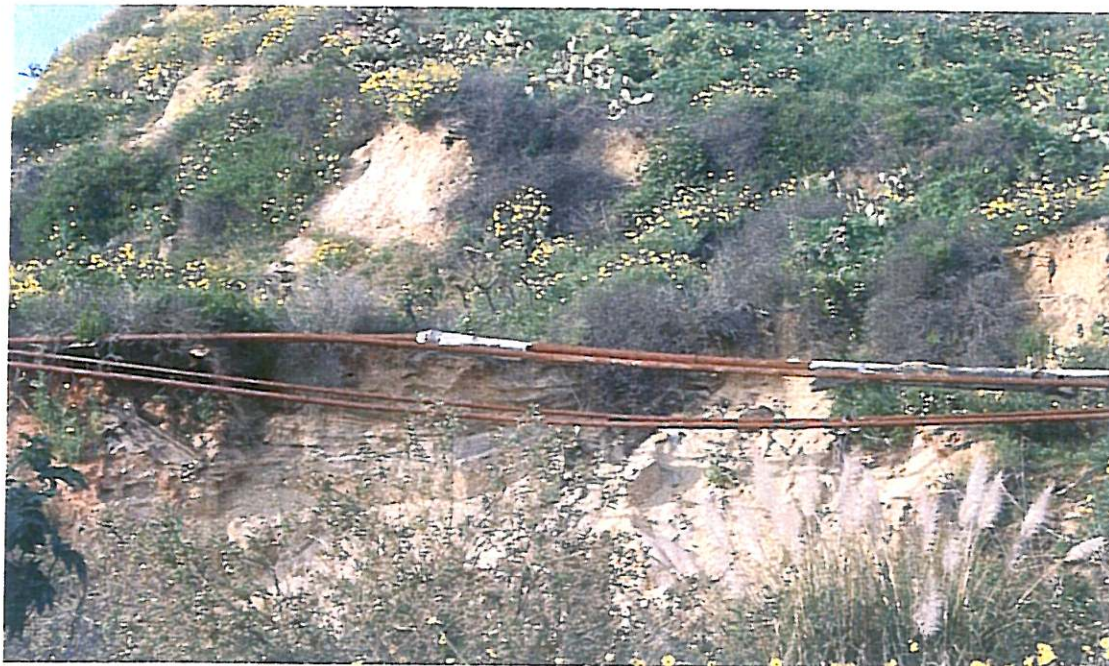
Photo No. 56      Photographer: Ryan Wohlstrom  
Description: Oil Pipeline - Absent Supports, Looking North.  
Project: Newport Banning Ranch, Orange County, California

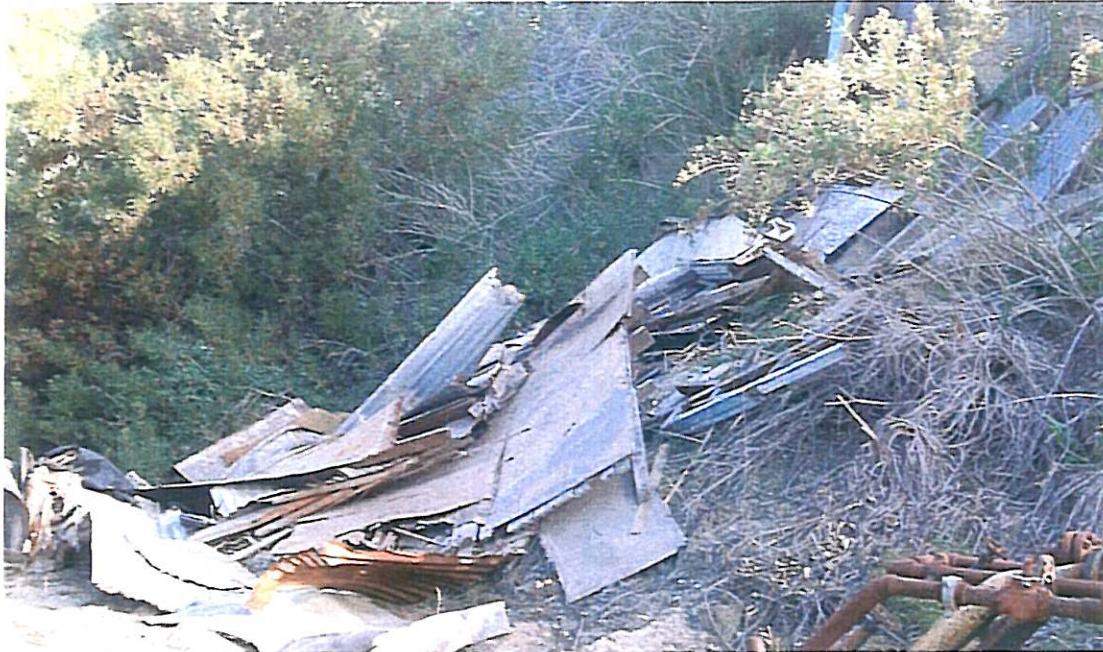
Photo No. 57      Photographer: Ryan Wohlstrom  
Description: Miscellaneous Debris, Looking East.  
Project: Newport Banning Ranch, Orange County, California

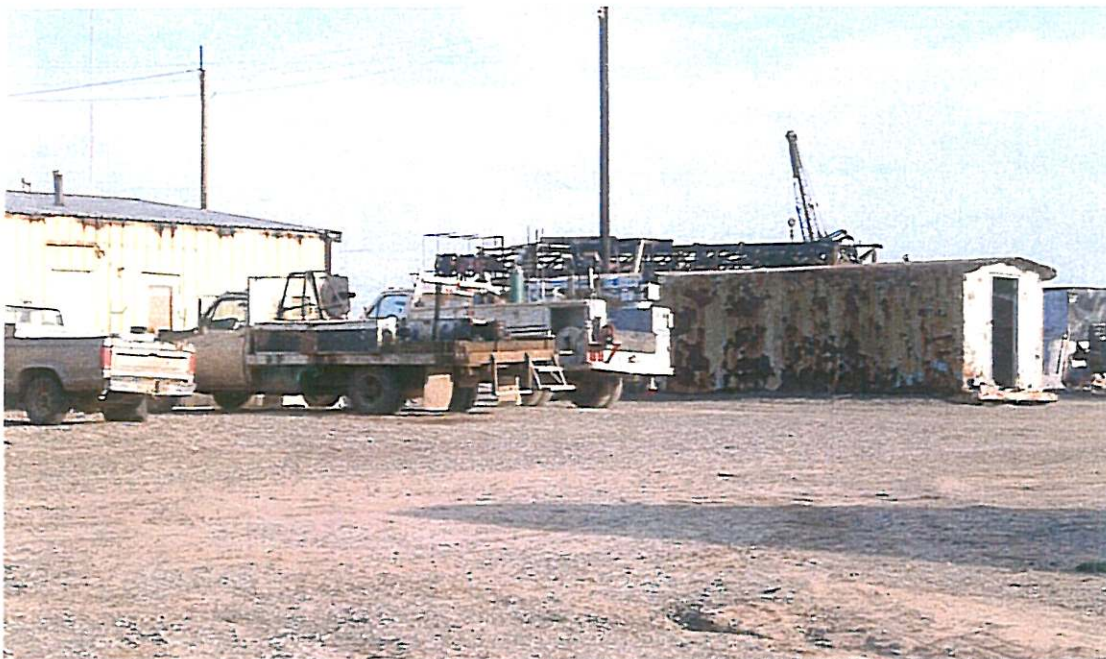
Photo No. 58      Photographer: Ryan Wohlstrom  
Description: Miscellaneous Equipment Storage Area, Looking Southwest.  
Project: Newport Banning Ranch, Orange County, California

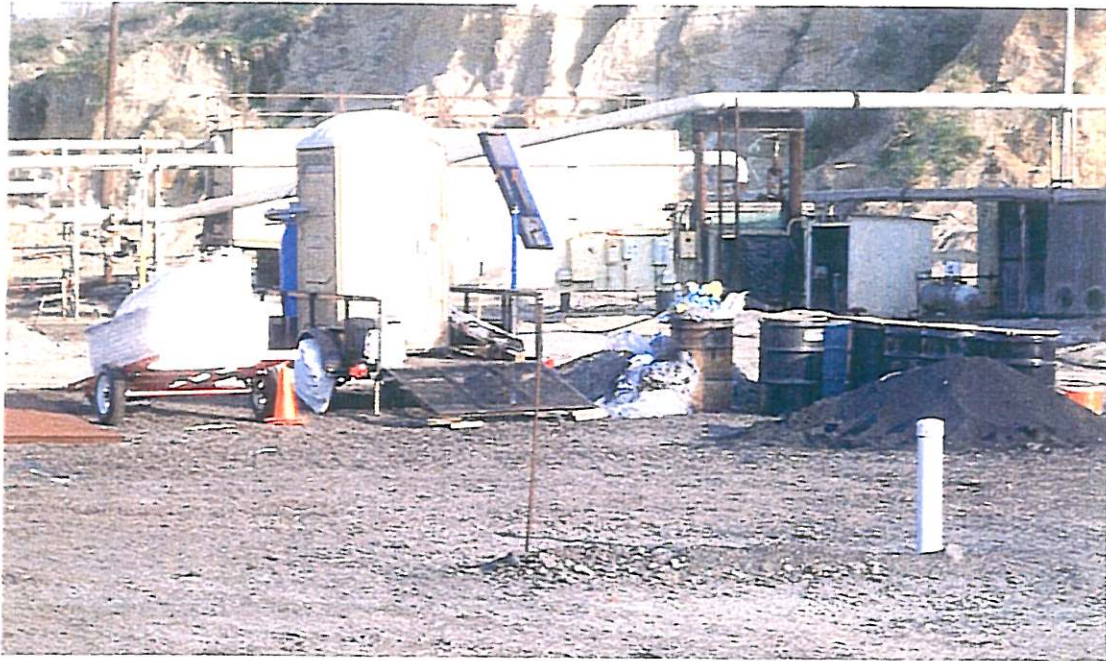
Photo No. 59      Photographer: Ryan Wohlstrom      Date: 12 March 2008  
Description: Solar Powered Belt Skimmer at Main Site Tank Farm, Looking East.  
Project: Newport Banning Ranch, Orange County, California
